Revised Total Coliform Rule – Level 2 Assessment Form

Florida Department of Environmental Protection

PWS ID#: 4501229 PWS Name: City of Riviera Beach Utility Special District City/Town: Riviera Beach

Exhibit 1 - RTCR MCL Violation Background

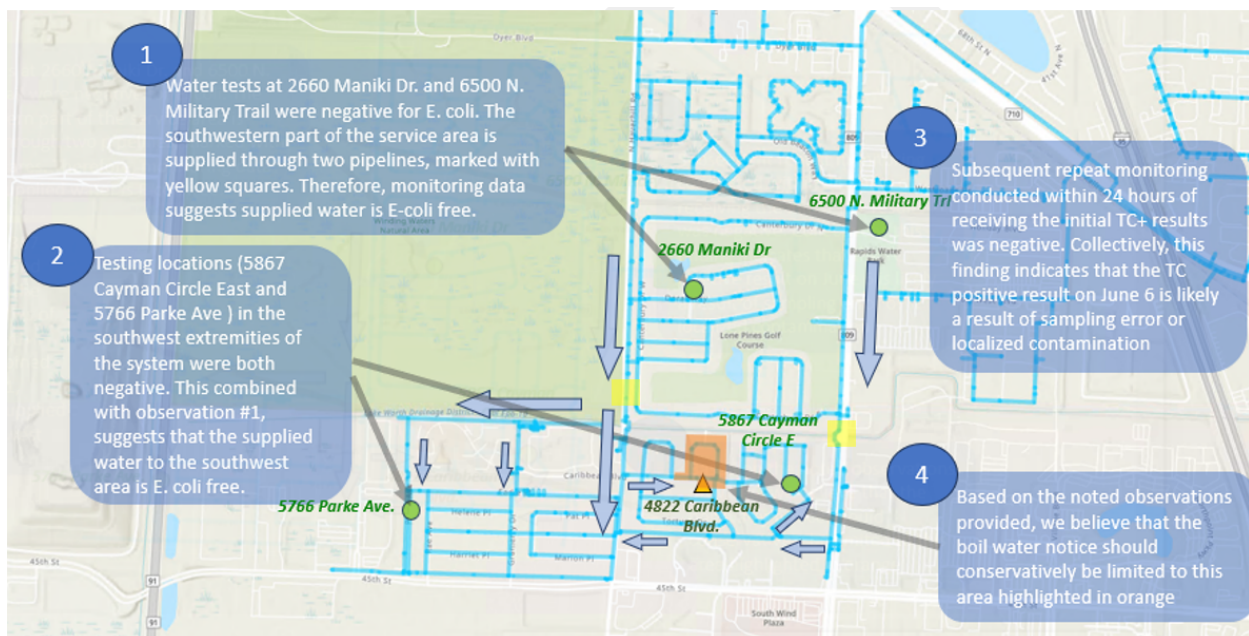
Figure 1. Directional flow of water at the southwestern part of RBUSD's distribution system. The highlighted area represents the predicted impacted area of the contamination event.

Additional considerations based on hydraulic modeling indicate that other areas in the system would not have been affected due to water flow directions (see Figure 1). Furthermore, the other seven (7) sites within the distribution system collected on the same day (June 6th, 2023) tested negative for TC and EC. Upon re-sampling on June 8th, 2023, they continued to show negative results, indicating that the impacted area was contained within SP #38 (near 4822 Caribbean Blvd). Ultimately, RBUSD failed to take the necessary steps to alert FDOH and adhere to the required testing protocols that follow a positive TC and EC sample. As a result, RBUSD incurred violations, necessitating a Tier 1 PN.

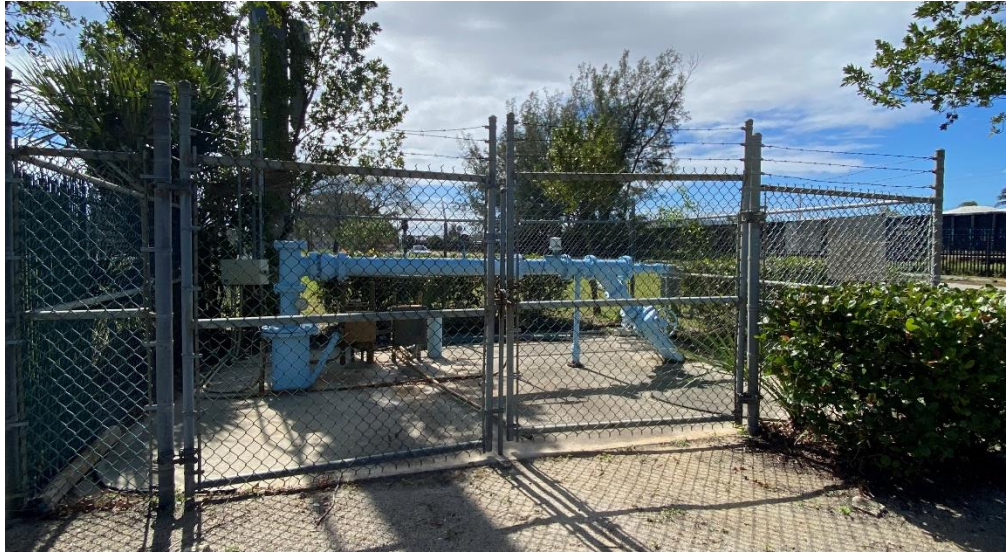
Figure 2. Well #14

Well #14 is located south of Blue Heron Blvd and west of Avenue 'H' W. (see Figure 2). On June 27th, 2023, lab samples collected from Well #14 tested positive for TC and EC.

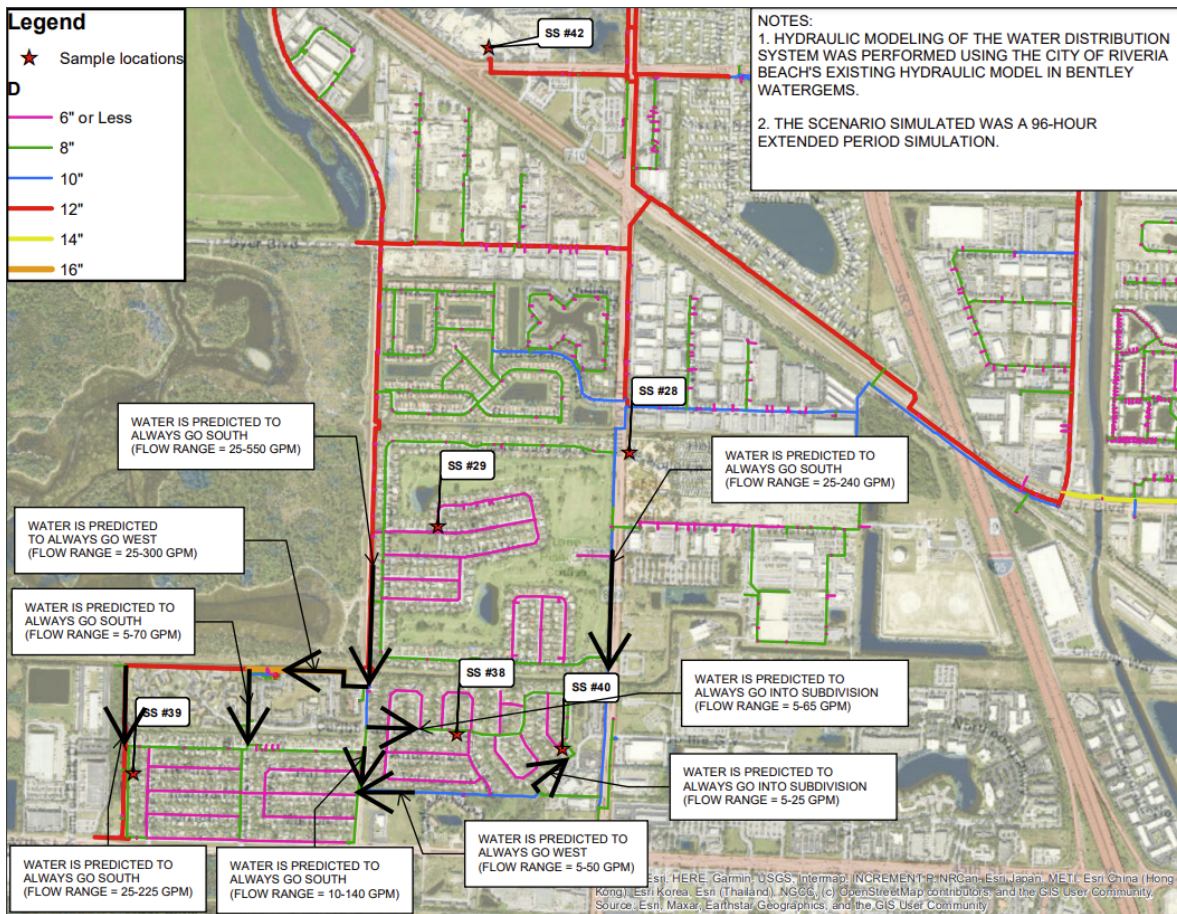
transmission corridors leading into the vicinity of SP #38. Flushing may be used as a method of increasing the turnover of water in this area. However, RBUSD staff noted that flushing can be challenging due to inadequate stormwater drainage in the area.

Figure 2. Initial hydraulic modeling results of water flow around SP #38

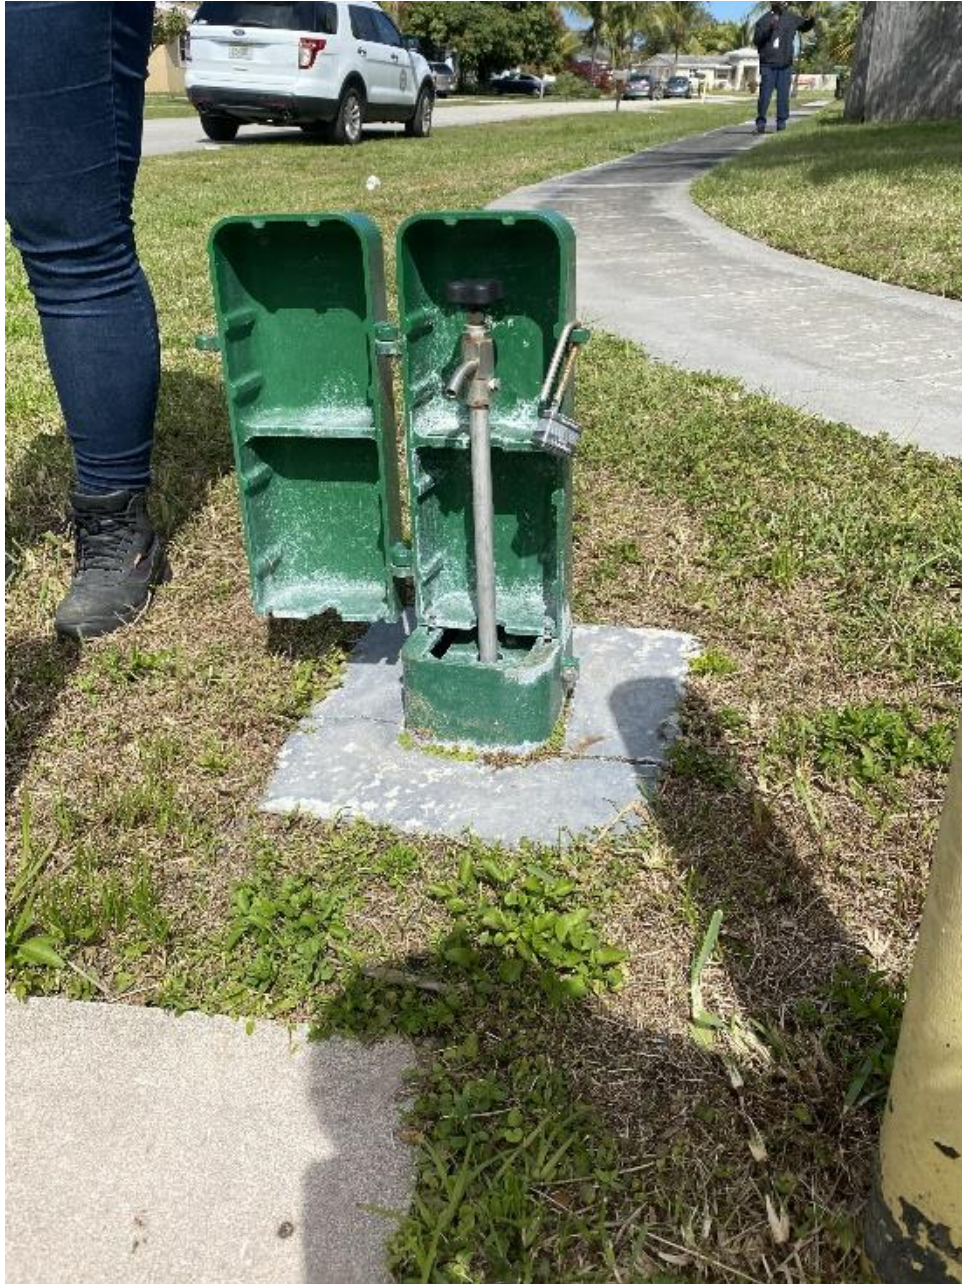
Figure 3. Photo of SP #38

The inspection involved a review of field conditions, site-specific factors that could impact water quality, and sample collection protocols. The water sampling sites are located in locked boxes to protect the smooth-nosed spigot from environmental and human/animal contact. RBUSD staff noted that ants and small insects sometimes enter the boxes, prompting sampling staff to inspect sampling stations to detect and remove insects prior to collecting samples. During the visit to the site, a dog approached the area and attempted to interact with the water flowing from the spigot while the lab tech was demonstrating its operation. Staff quickly intervened to remove the dog and close the protective box around the spigot, recognizing the potential contamination risk posed by the dog's interaction with the water. Sampling demonstration procedures continued once the dog was safely removed. The laboratory technician confirmed that such an encounter was not uncommon. The staff is aware of animals that may approach them during testing, and they follow proper procedures to remove any potential contamination risk promptly. Testing only proceeds once the risk, such as the presence of animals, is effectively mitigated. Refer to Figure 3 for a photo of SP #38 with the protective box opened.

Readily observable elements of SP #38 appear to be appropriately installed and well-suited for its use as a routine RTCR monitoring location. The area was free of visible conditions, indicating a potential sanitary hazard that requires corrective measures. Consequently, no permanent condition was observed that would indicate an increased vulnerability to contamination of the sampling site. Since the inspection was conducted over eight (8) months after the TC+ sampling event on June 6th, 2023, observed conditions may not represent the field conditions that existed at the time. However, the site visit identified the following areas for additional investigation:

1. Update the GIS record to align with actual field conditions (within 60 days).
2. Further assess the need for and approach to periodically flushing the area, with the goal of improving the water turnover in the area (within 60 days).
3. Conduct limited sampling for typical nitrification indicators (nitrite, nitrate, pH, alkalinity, and free ammonia) near SP #38 to determine if nitrifying activity could impact residual levels (within 60 days).

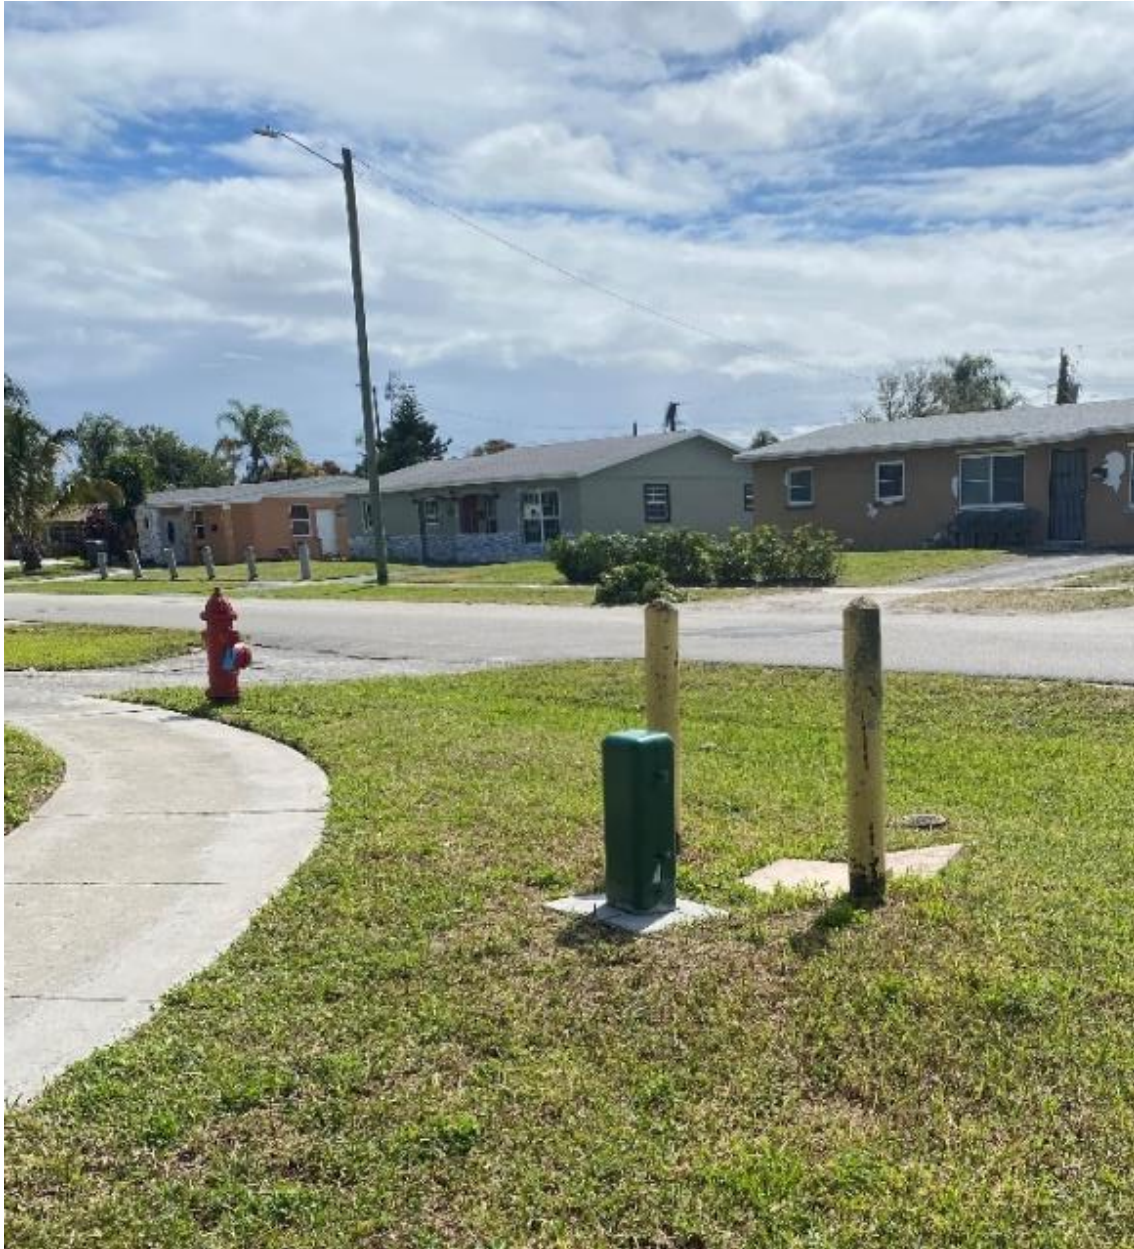
Figure 4. Proximity of SP #38 to Fire Hydrant

SP #38 is situated within approximately 20 feet of a fire hydrant (refer to Figure 4) and is reportedly tapped directly into the distribution water main via a 2-inch tap that's reduced to a 1-inch feed line to the SP. Subsequent to the site visit, RBUSD furnished a GIS map to the consultant's team to assess the connection points to SP #38. However, the map did not depict SP #38 to be positioned where it was observed in the field, and water main connection details were unavailable from the GIS maps. Specifically, RBUSD compliance staff indicated that the water main is believed to be in the roadway; however, the GIS map indicated that the water main is located in the unpaved shoulder. Furthermore, no pavement cuts were observed in the roadway at locations that would be expected for a recently installed connection to the water main.

During the June 6th, 2023 monitoring event, the observed chlorine residual collected from SP #38 was lower than samples collected from nearby routinely monitored sites supplied from the same transmission mains. It was recommended that the actual connection of the SP to the water main be verified. RBUSD took immediate action to uncover the sample line and confirmed that it was appropriately installed on the water main (note – the sample line for SP #39 was also uncovered and verified to be appropriately installed on the water main).

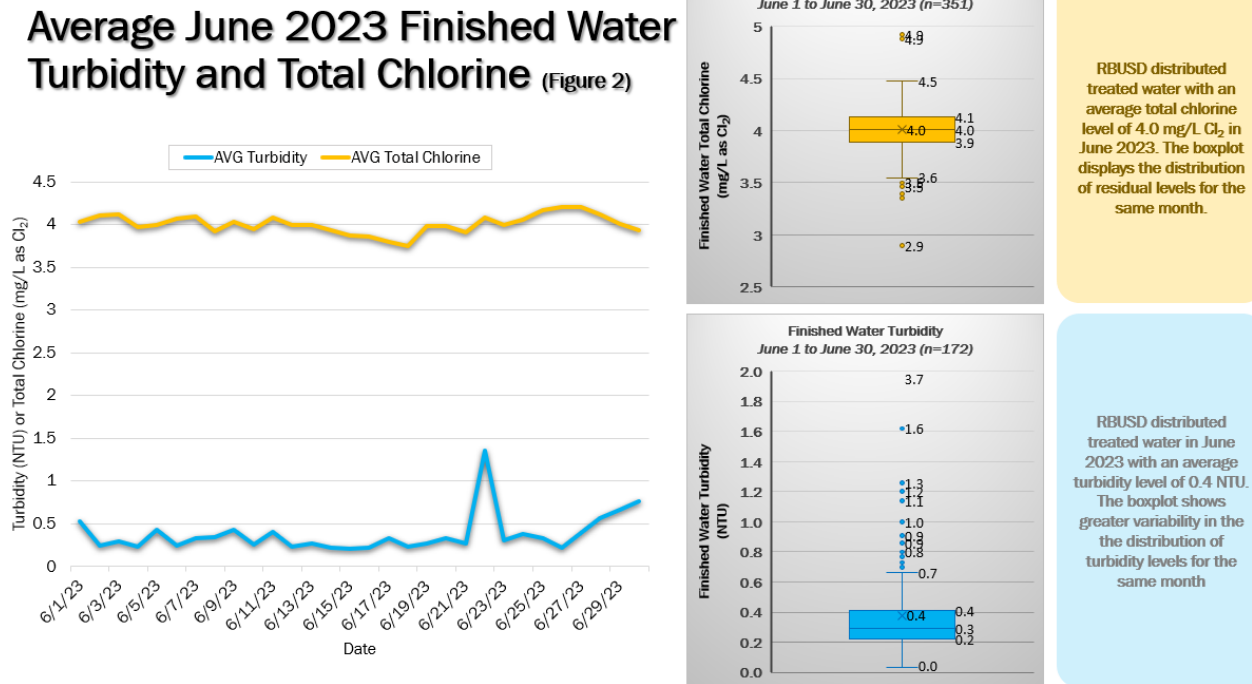
Figure 2. RBUSD's June 2023 Daily Average Finished Water Turbidity and Total Chlorine Levels

2. Turbidity levels showed more variability than chlorine residual, with a spike and increasing trend noted towards the end of the review period. Turbidity produced in lime softening plants is generally due to calcium carbonate particles generated in the softening process and subsequently breaking through the filtration process. While turbidity levels were generally within the typical range for much of the review period, further assessment of the potential cause of performance instability should be investigated further, and appropriate improvements should be implemented. It should also be noted that historically, elevated turbidity levels in the filtered water have resulted in an accumulation of calcium carbonate

deposits in the system, which has been the source of customer complaints and can impair the hydraulic capacity of the transmission system.

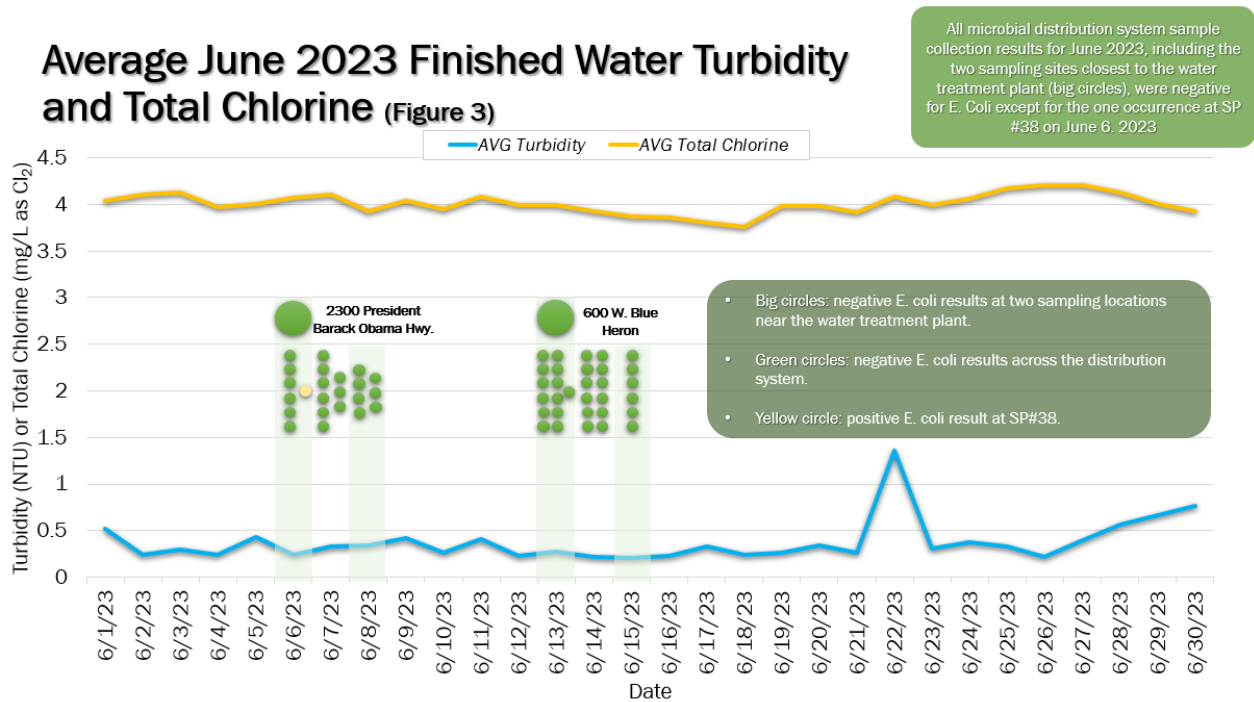
In Figure 3, the distribution TC monitoring results are overlaid on the finished water turbidity and chlorine residual results to graphically relate the key plant operating parameters to the observed microbial water quality in the distribution system. On June 6th, the date SP #38 produced a TC+ result, seven (7) other distribution sites were monitored, including the location near the WTP, and all system locations yielded negative TC results.

Figure 3. RBUSD’s June 2023 Daily Average Finished Water Turbidity and Total Chlorine Levels with the Distribution System Microbial Sample Collection Results

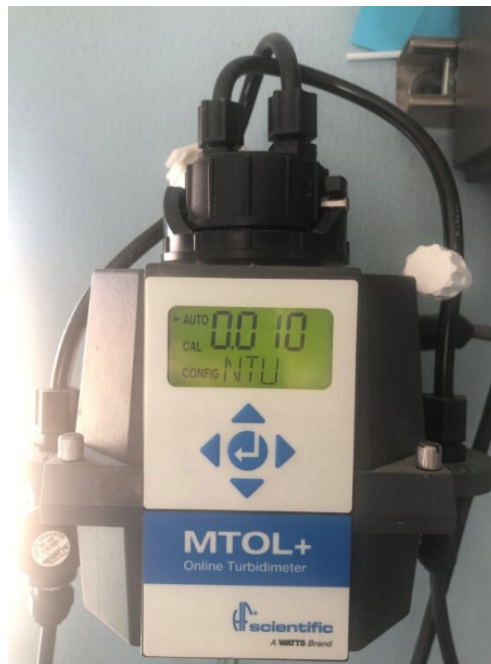
Figure 4. MTOL+ Turbidity Meter

4. An online finished water turbidity meter was observed to produce a result inconsistent with expectations, and the manually sampled data (see Figure 4). It is noted that this instrument is not relied upon for reporting purposes; however, if functioning as intended, it can provide useful early notification of turbidity excursion, performance trending, and an independent backcheck of manually recorded data.

To mitigate these limitations, it is recommended that RBUSD assess the impediments to maintaining the operability of available monitoring equipment and implement required training, procedural, and

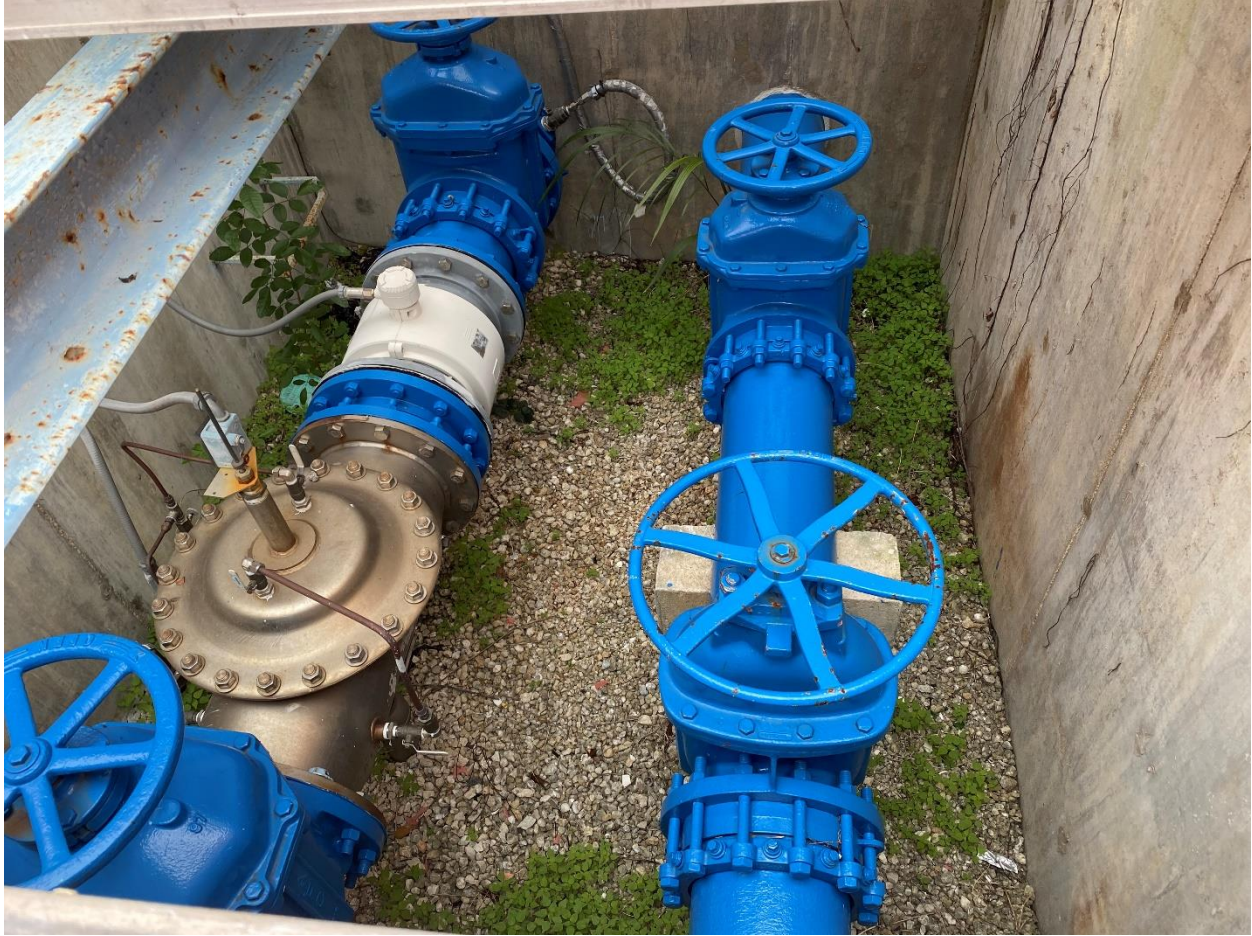
Figure 3. Fill and Flow Meter Vault

3. Discharge Flow Meter – the discharge from the high service pumps is fitted with a venturi meter intended to monitor and report flows discharged from the Avenue U facility. The flow meter and associated instrumentation were observed to be inoperable and did not appear to have been maintained for a long time. Attempts by RBUSD staff to vent the sensor line (which is under system pressure) failed to produce any fluid flow, which indicates the line may be plugged.

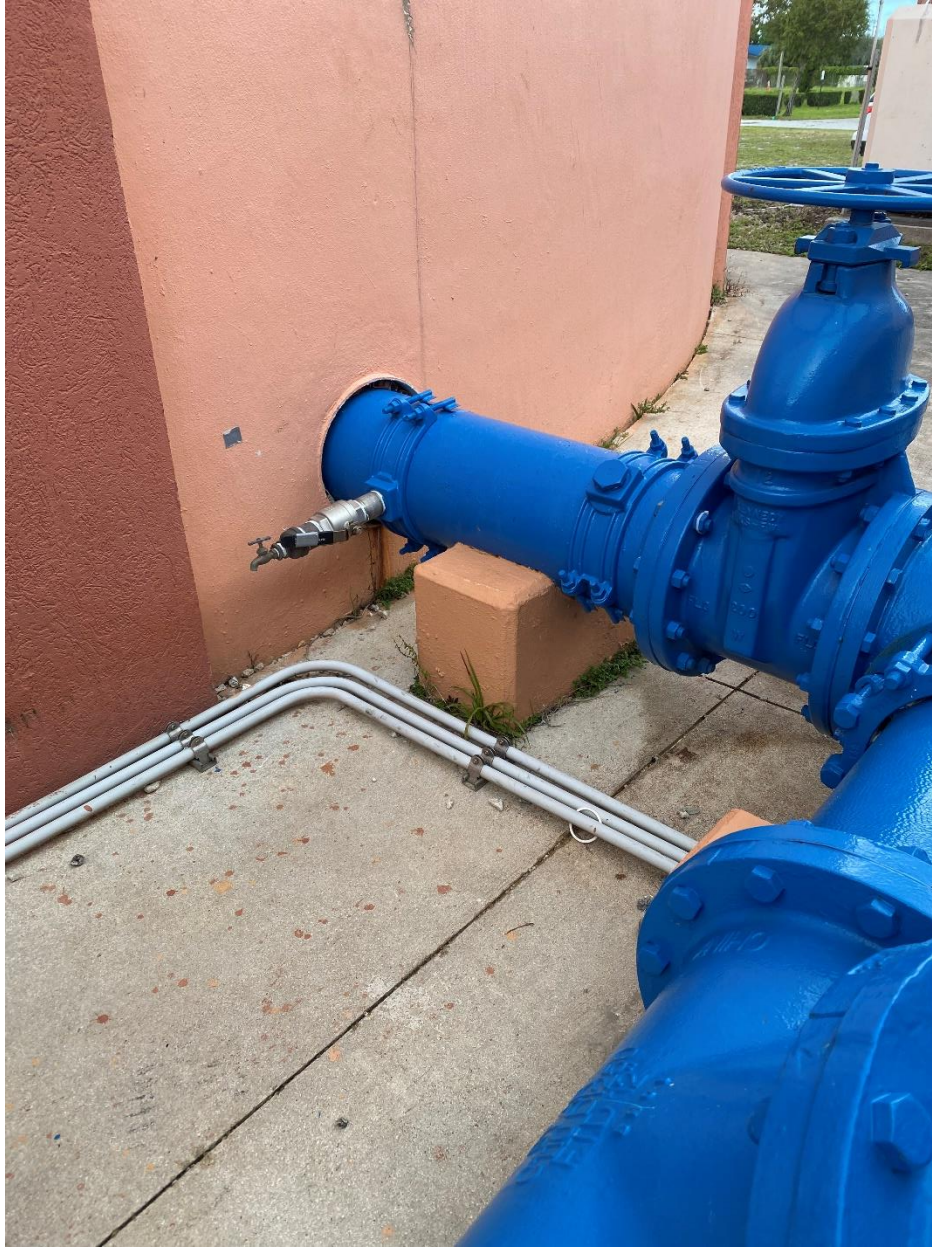
Figure 4. 12" Ductile Iron Pipe Watermain. Note: The water sample for total chlorine residual (4.4 mg/L) was collected from the discharge of the tank here.

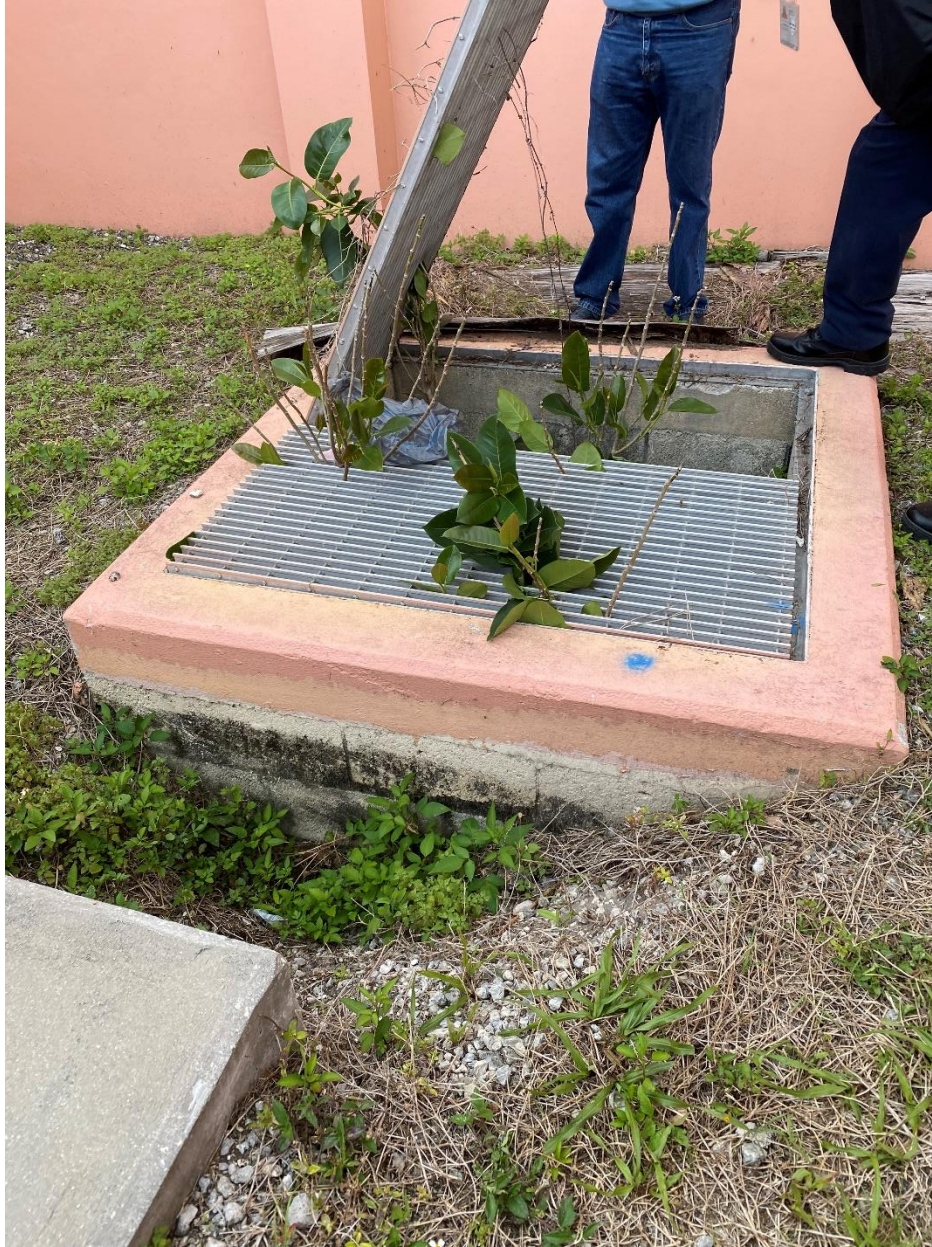
4. Miscellaneous Observations – excessive vegetation growth was observed in the tank drain vault (used to receive various water streams intended to be discharged to waste) during the site visit. Chase water used for the operation of the residual analyzers represents a steady and continuous discharge into the tank drain vault that should be metered or otherwise estimated for proper accounting of authorized unmetered water demands that must be reported as part of RBUSD's Water Use Permit (WUP).

Figure 8. Vegetation Growth in the Tank Drain Vault

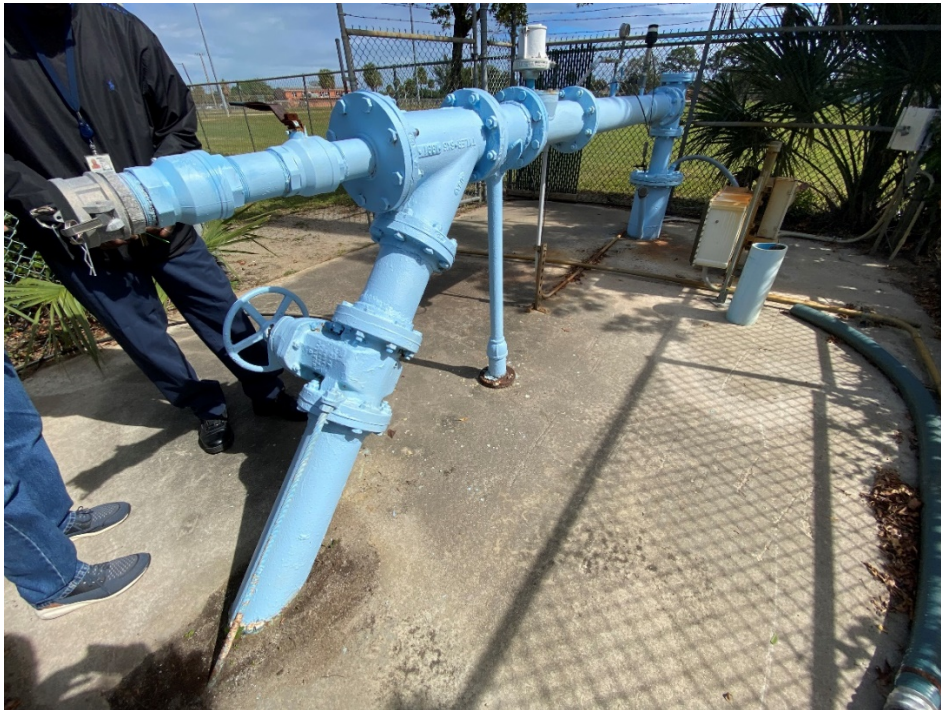
Figure 1. Well #14 Discharge Piping

An important focus of this site visit was to review the well isolation protocols and identify opportunities for improvement. The RBUSD standard practice is to isolate any raw water supply well from the transmission system whenever a well sample tests positive for total coliforms. Other conditions that may trigger well isolation include removal from service for maintenance, bacteriological clearance, or other conditions requiring extended standby durations. A site visit to Well #14 was conducted on February 22nd, 2024, during which the isolation protocol was reviewed with WTP Operations Manager (Melvin Pinkney). The photographs below show the general configuration of Well #14 at the time of the site visit.
