Revised Total Coliform Rule – Level 2 Assessment Form

Florida Department of Environmental Protection

PWS ID#: 4501229 PWS Name: City of Riviera Beach Utility Special District City/Town: Riviera Beach

Exhibit 1 - RTCR MCL Violation Background

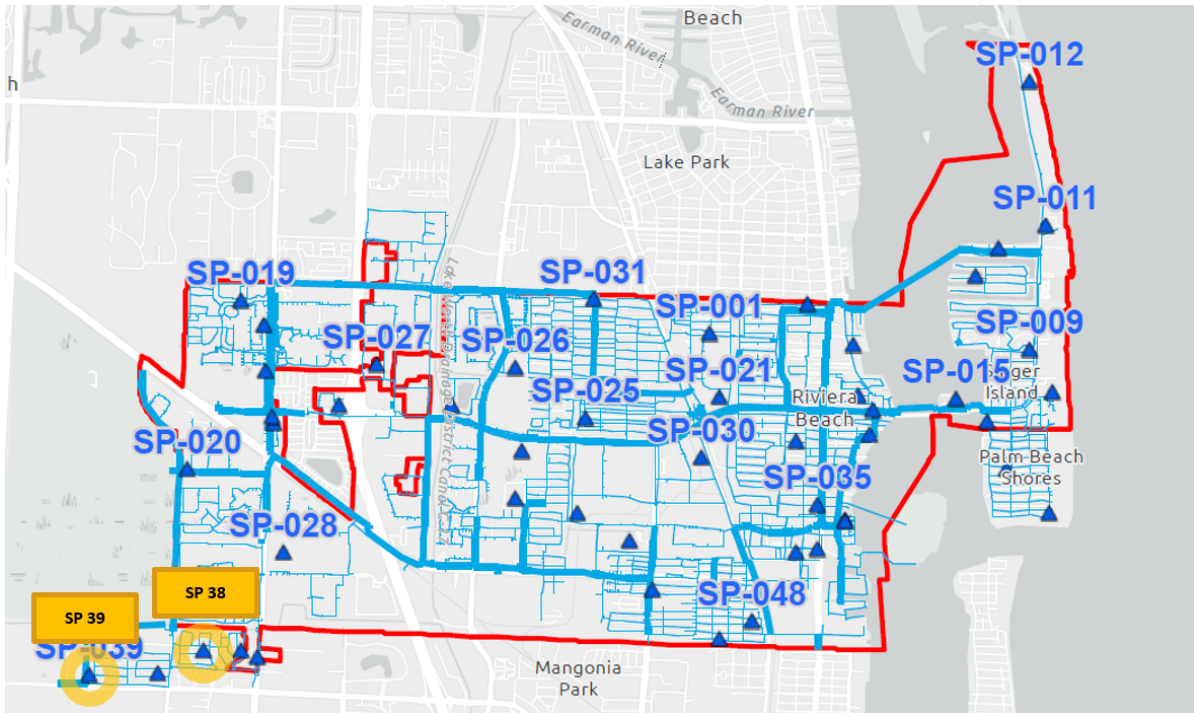
Figure 1. Sampling Sites within RBUSD

During the site visit, SP #39 was also inspected due to similarities in configuration and its hydraulic location, which is more distal relative to SP #38. Both sites are among the routinely monitored distribution system’s microbial sample collection sites under the RTCR. Refer to Figure 1 below for SP #38 and SP #39 locations relative to the Water Treatment Plant (WTP) and all other monitoring sites. Other routine monitoring sites that were also sampled on June 6th, 2023 (the date SP #38 tested positive for total coliforms) are also highlighted in Figure 1. SP #38 is located at the southwesternmost extremity of the water distribution system, specifically within Grammercy Park, an unincorporated part of Palm Beach County.

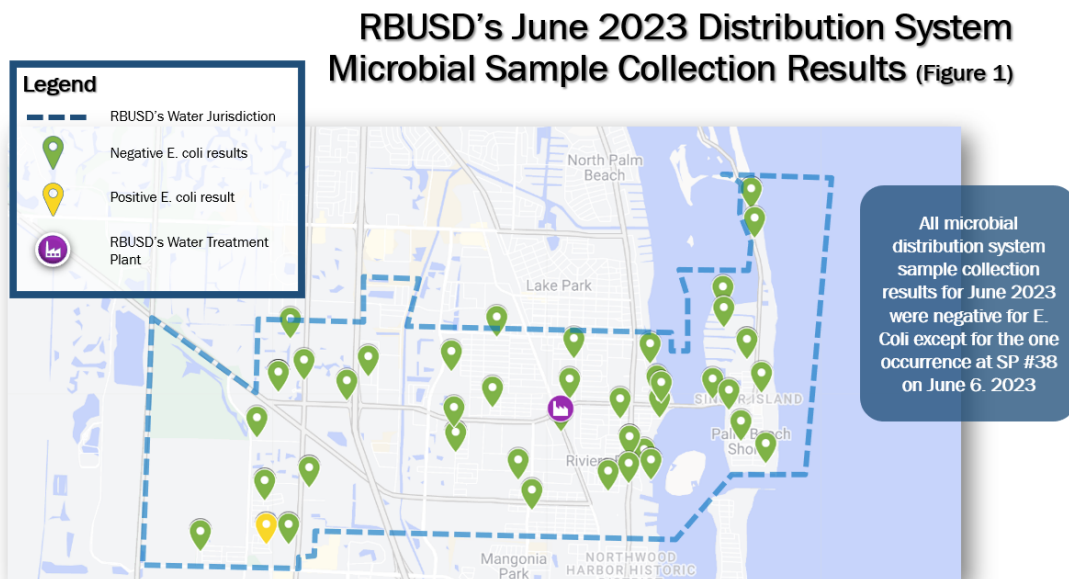
Figure 1. RBUSD's June 2023 Distribution System Microbial Sample Collection Results

The analysis previously presented in Exhibit 1 demonstrated that there is no indication that the performance of the WTP had an impact on the TC+ result from SP #38 that occurred on June 6th, 2023. The following combined facts support this finding, which is illustrated in Figure 1:

1. Remote hydraulic extremity of SP #38 from the WTP (refer to Figure 1)
2. Seven (7) sample sites located between the WTP and SP #38, including one site in close proximity to the water treatment plant (2300 President Barack Obama Hwy), were also sampled on June 6th, 2023, and tested negative for TC.
3. Results of hydraulic modeling, coupled with monitoring data for nearby sites, demonstrate that the zone of uncertain water quality is limited to a few homes near SP #38 (refer to Exhibit 1).

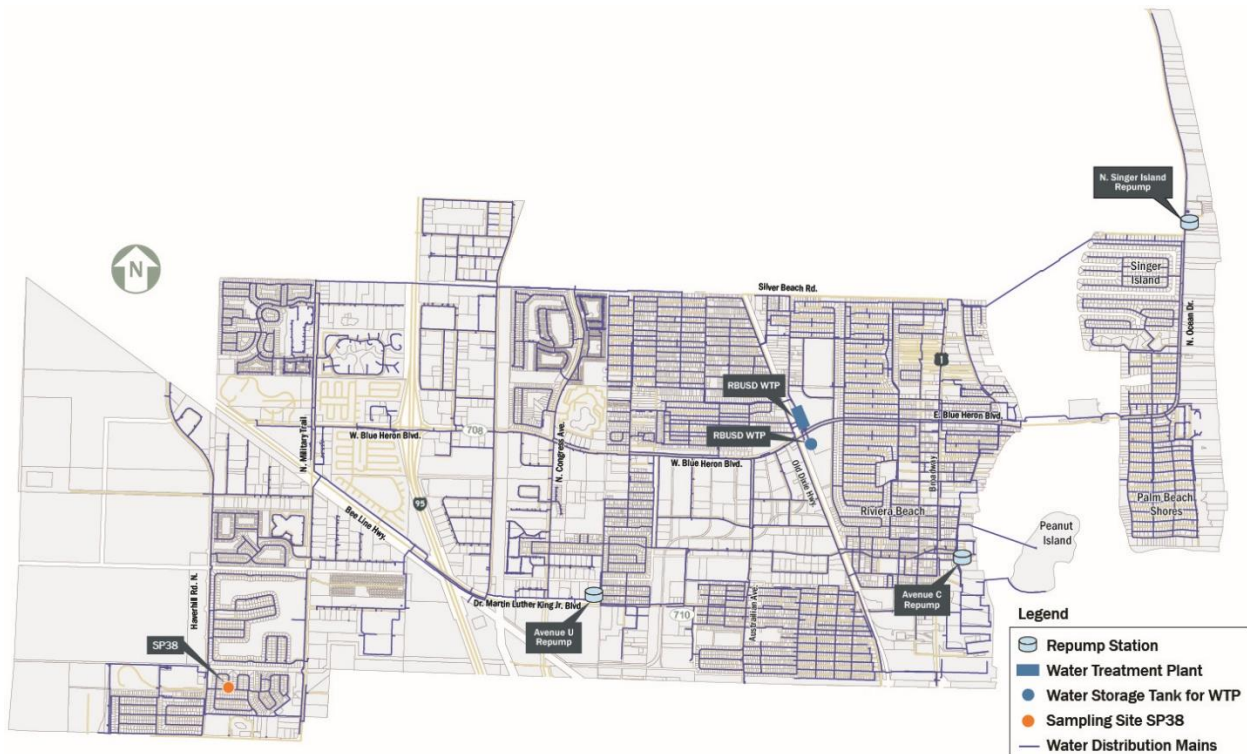
Figure 1 RBUSD Distribution System Map

RBUSD owns and operates the following three distribution system storage and repump stations: 1) Avenue C Storage and Repump Station (1.0 mgal capacity); 2) Singer Island Storage and Repump Station (1.0 mgal capacity); and 3) Avenue U Storage and Repump Station (1.0 mgal capacity). A map of the distribution system showing the location of each storage facility relative to SP #38 and the WTP is shown below in Figure 1.

Based on the configuration of the water distribution system, the only storage/repump facility capable of directly impacting the quality of water delivered to SP #38 is the Avenue U storage/repump facility. Consequently, this facility is the focus of this component of the Level 2 Assessment. Brown and Caldwell conducted a site visit on February 22nd, 2024 to inspect the facility. The inspection was limited to readily observable conditions that could be viewed from ground level without climbing structures, entering confined spaces, opening electrical cabinets, or activating equipment. Key findings from the site visit are summarized below:

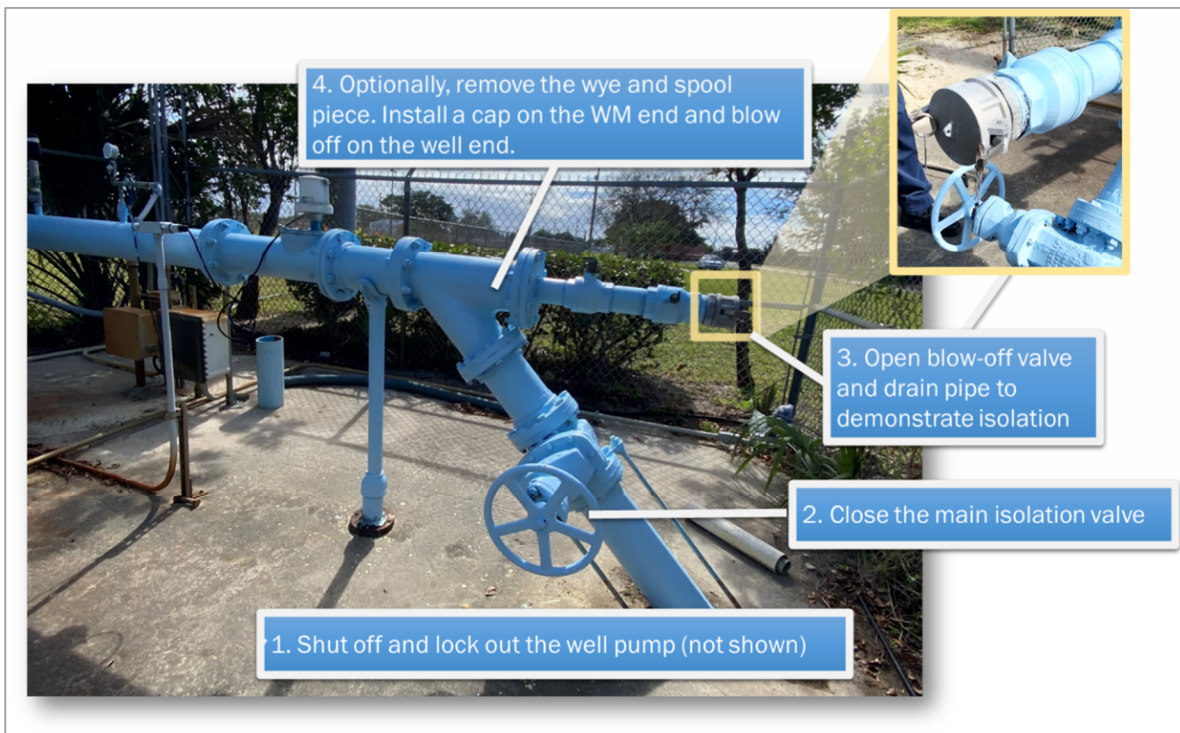
Figure 2. Major Well Isolation Elements

The protocols used to isolate Well #14 from the raw water transmission system are summarized below. Refer to Figure 2 to visualize the well isolation steps indicated below.

1. Shutoff and lock out the well pump.
2. Close the main well isolation valve (refer to Figure 2).
3. Open the blow-off valve to allow horizontal alignment of well discharge piping to drain (evidenced by no discharge from blow off). Cessation of water discharge from blow off is used as an indicator of a tight seal in the closed well isolation valve (against a back pressure of approximately 20 psi in the raw water transmission main). During the inspection, isolation of Well #14 was demonstrated to be successfully achieved using this standard.

5. Upon successfully isolating the well from the raw water transmission system, the well pump is activated, and all produced water is continuously discharged through the blow off connection.

6. Samples required for bacteriological clearance are collected from a sampling spigot located immediately downstream from the wellhead.
